MERRIMACK RIVER BASIN  
FRAMINGHAM, MASSACHUSETTS

FOSS RESERVOIR DAM  
MA00339

PHASE I INSPECTION REPORT  
NATIONAL DAM INSPECTION PROGRAM

APRIL 1981

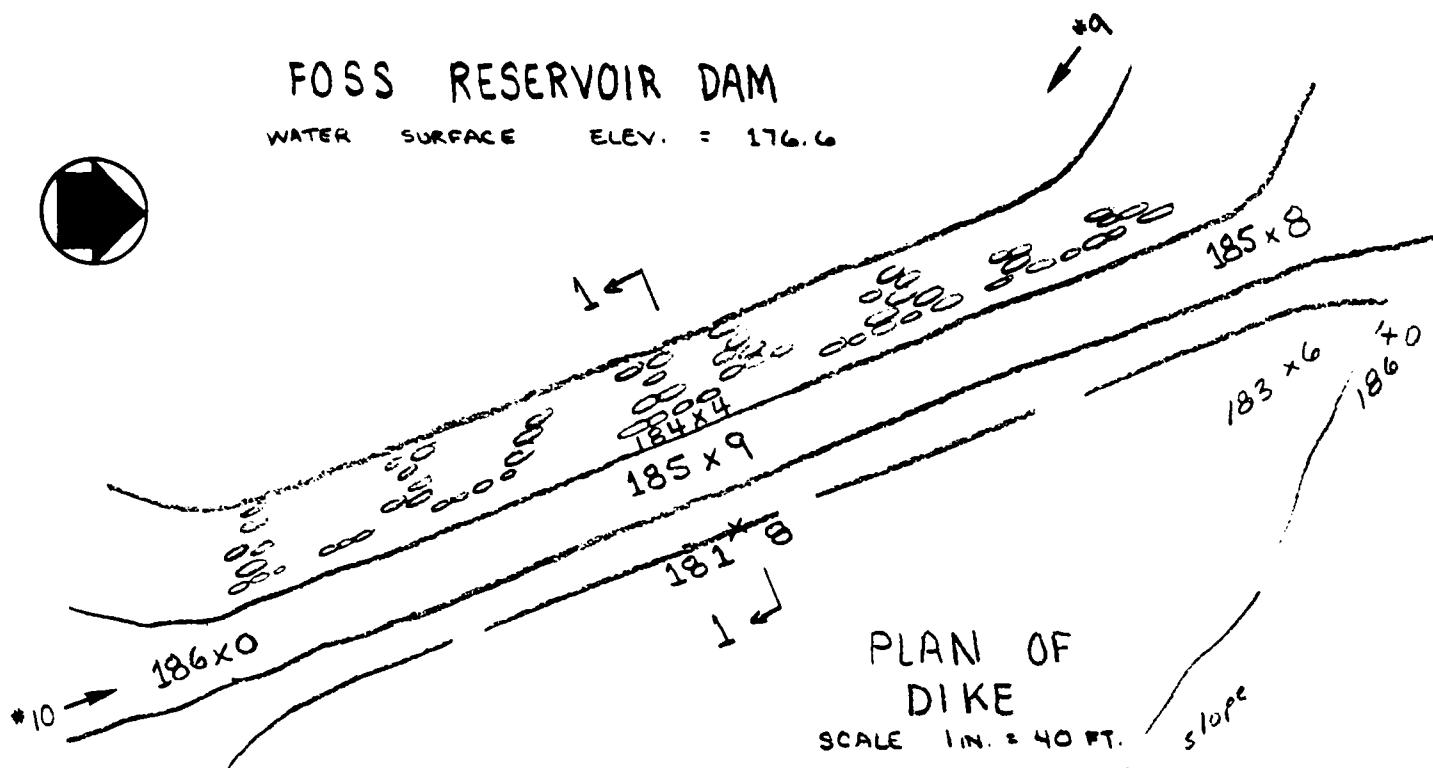
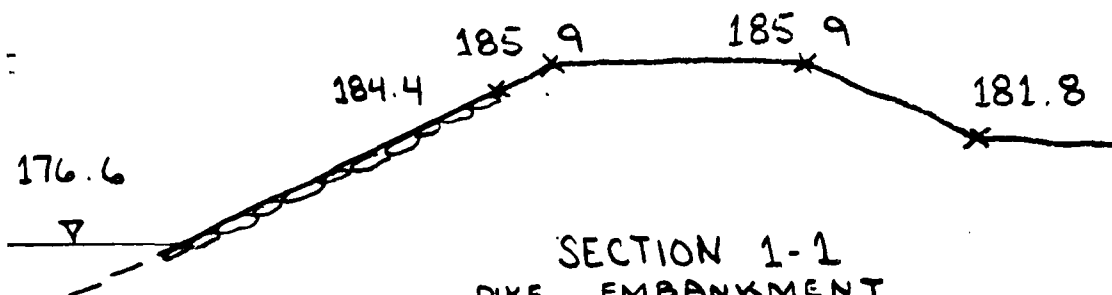
1. Elevations shown based on spillway crest elevation 179.59 (NGVD) taken from the Metropolitan District Commission records.
2. Information shown based on field inspection of December 5, 1980.
3. No. 2 indicates location and direction of view for photographs.
